# **Intel<sup>®</sup> Core<sup>™</sup> Duo Processor and Intel<sup>®</sup> Core<sup>™</sup> Solo Processor on 65 nm Process**

**Specification Update**

***April 2006***

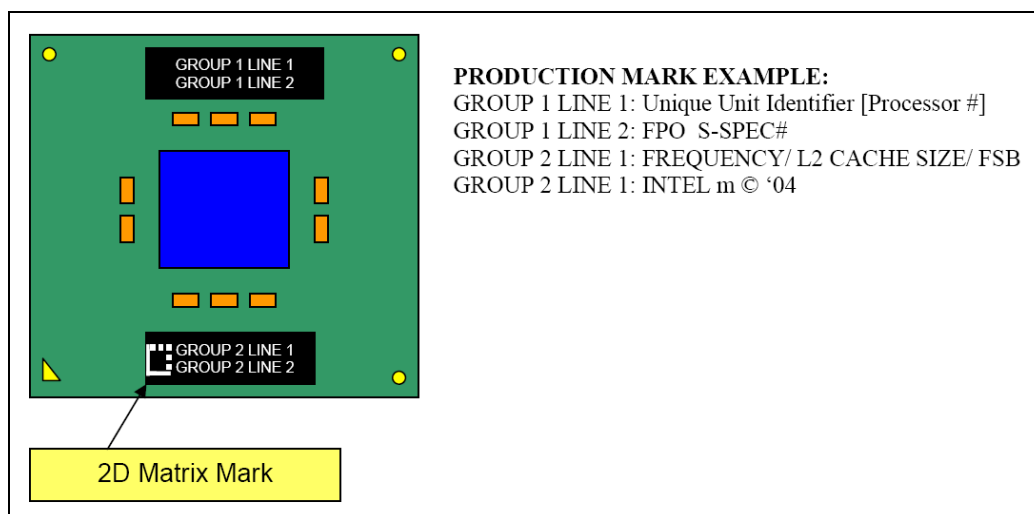
**Figure 1. Intel Core Duo Processor and Intel Core Solo Processor on 65 nm Process (Micro-FCPGA/FCBGA) S-Spec Markings**
